Aransas National Wildlife Refuge - Dagger Point

# Dagger Point Coastal and Marine Habitat Protection and Restoration

## San Antonio Bay Partnership 10th Anniversary Conference & Celebration

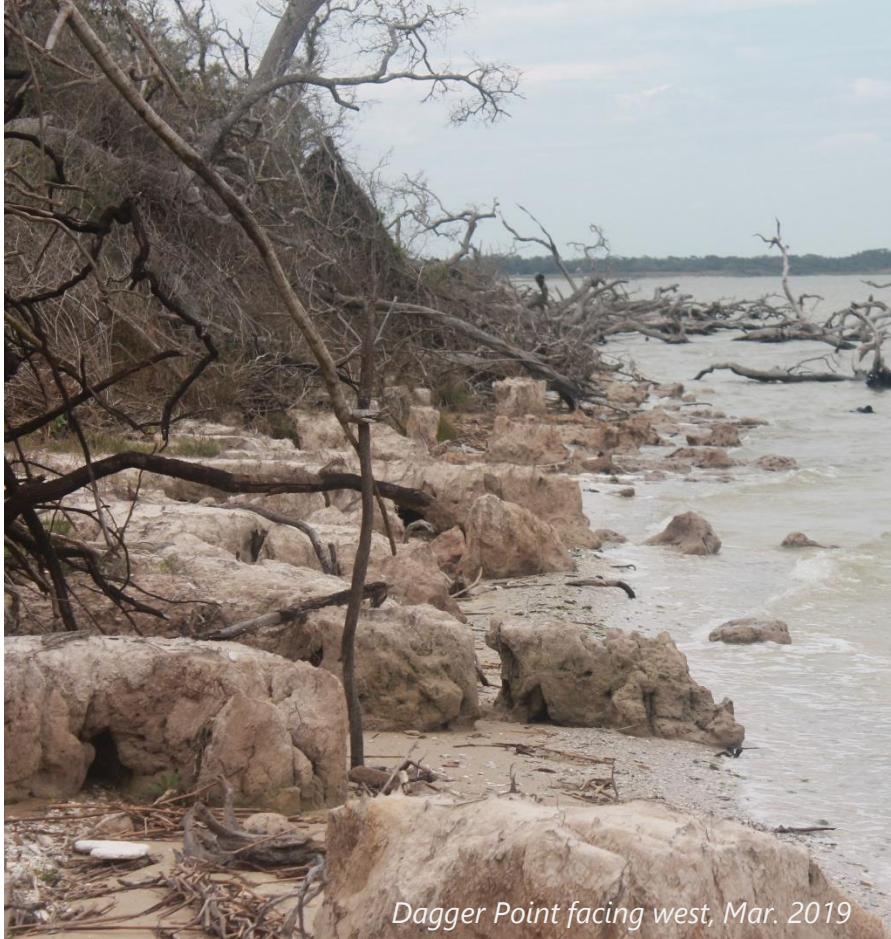
*Dagger Point facing west, Mar. 2019*

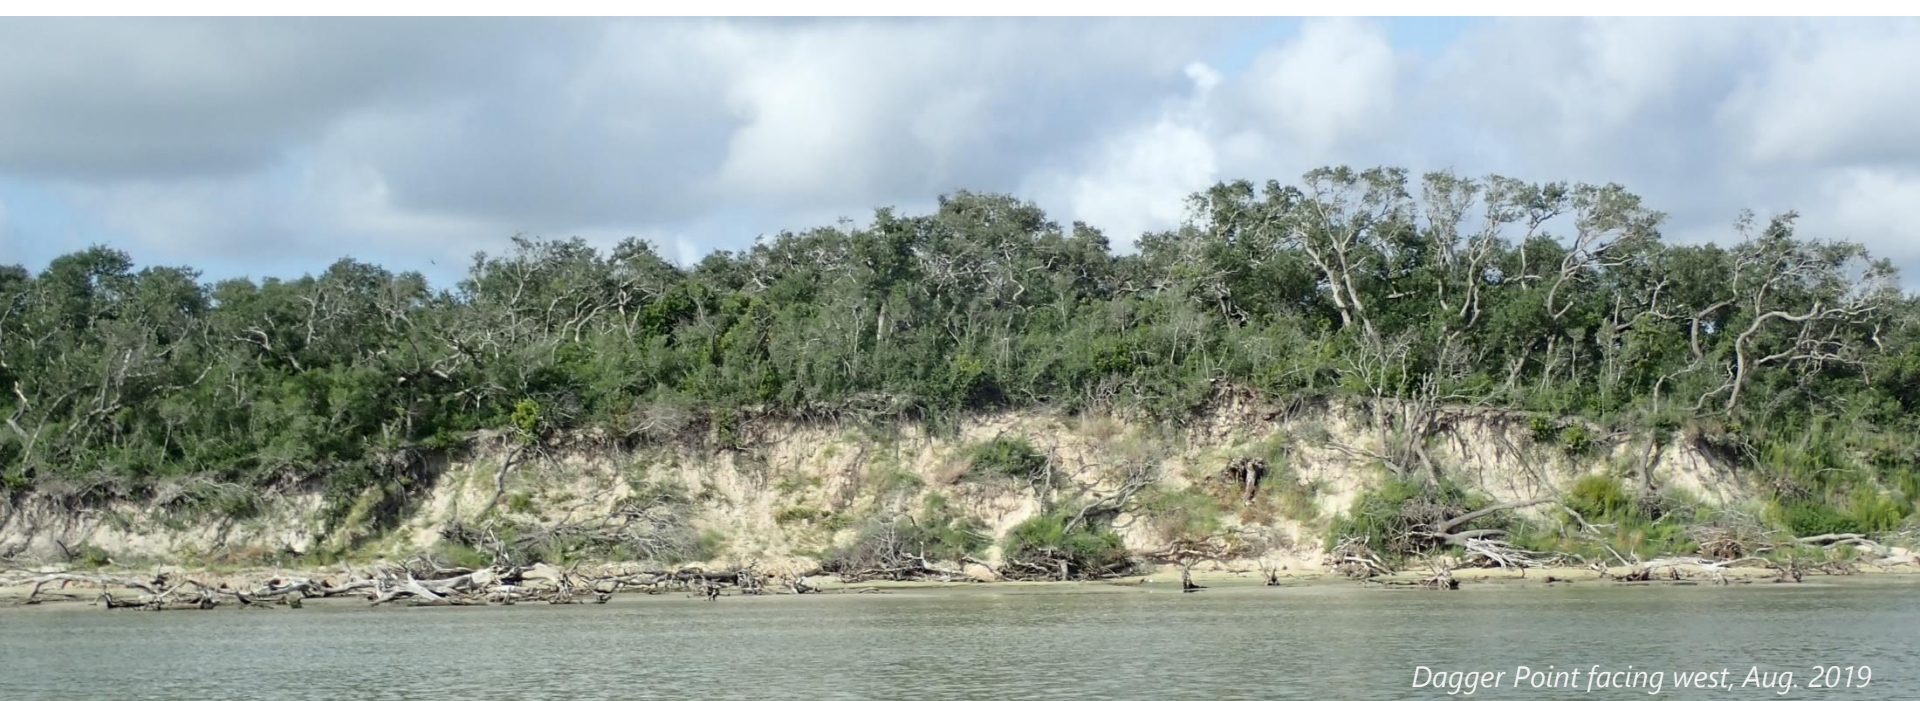
*Dagger Point facing west, Aug. 2019*

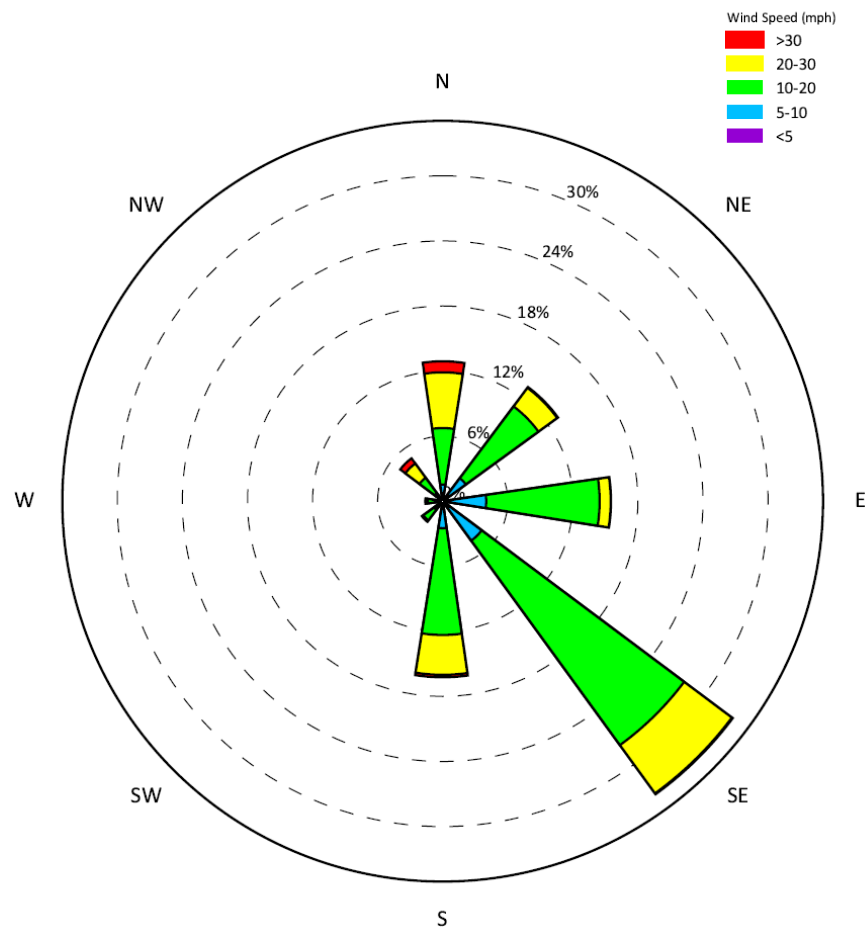
- Wind Rose
  - Predominant winds from southeast
  - Intense, Low frequency, winds from north

Hourly Wind Data Obtained from USACE WIS Station 73046 for Years 1980 through 2014  
Calm and Variable Winds: 0.0%  
Maximum Recorded Wind Speed: 53.7 mph  
Wind data are presented as the "blowing from" direction.

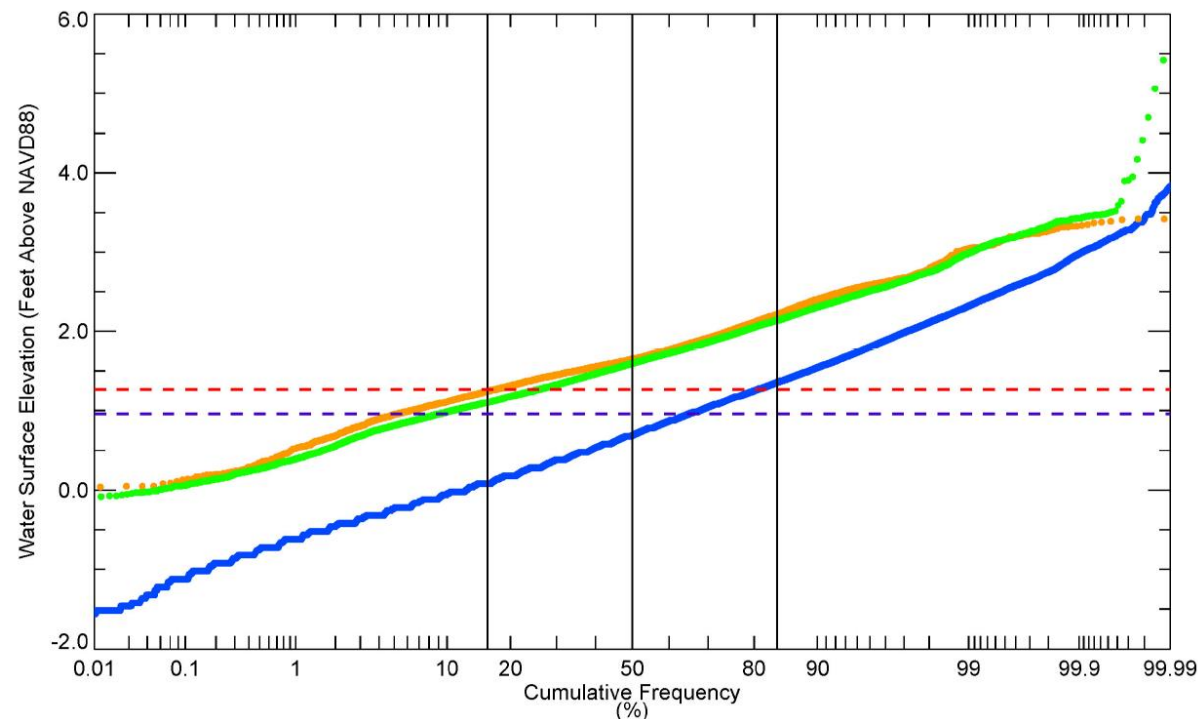
- Cumulative Freq. Dist. of Water Surface Elevation
  - MHHW is 1.27-ft (above NAVD88)
  - MLLW is 0.96-ft (above NAVD88)

- Measured Hourly WSEL at Rockport, TX (NOAA 8774770 - All Available Data, 1937 to 2019)
- Measured Hourly WSEL at Rockport, TX (NOAA 8774770 - October 2018 to September 2019)
- Measured Hourly WSEL at Aransas WLR, TX (NOAA 8774230 - November 2015 to August 2019)
- MHHW at Dagger Point Project Site
- MLLW at Dagger Point Project Site

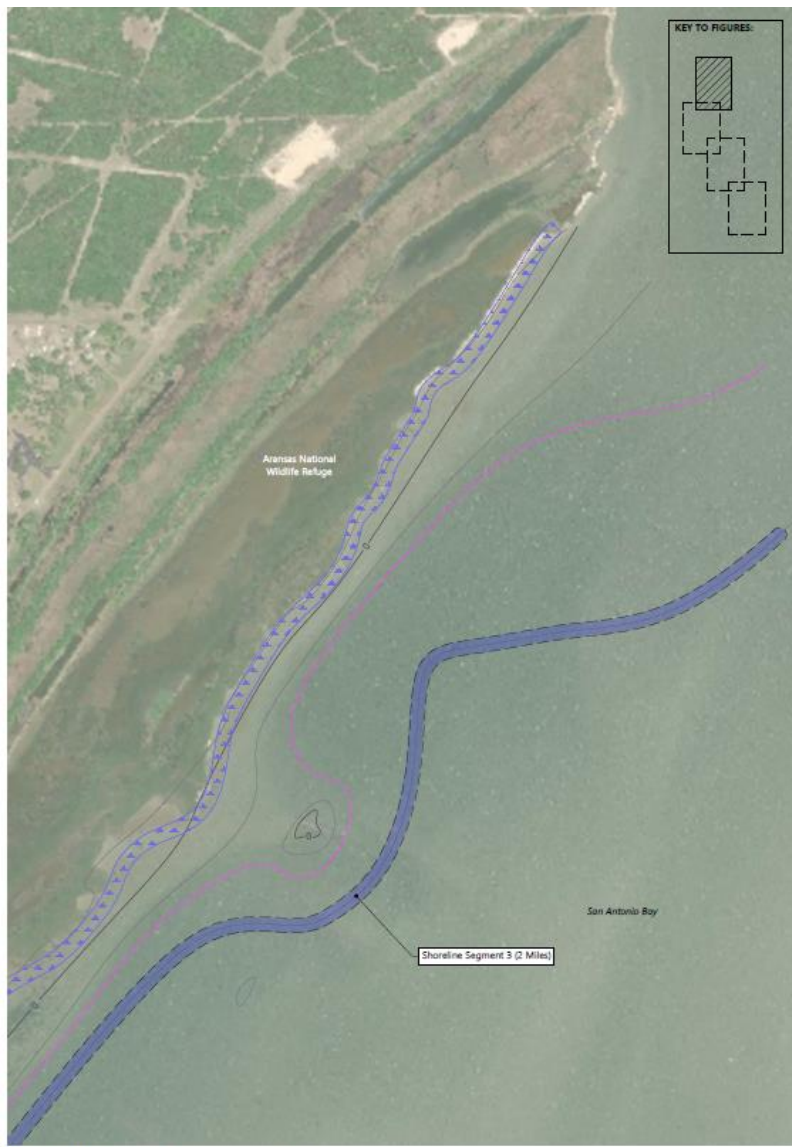
**SOURCE:** ©2019 Microsoft Corporation ©2019 DigitalGlobe ©CNES (2019) Distribution Airbus (DS)  
**HORIZONTAL DATUM:** Texas State Plane South Central, North American Datum of 1983 (NAD83), U.S. Survey Feet  
**VERTICAL DATUM:** North American Vertical Datum of 1988 (NAVD88)  
**NOTE:** Gap spacing and dimensions between breakwater segments to be determined during advancement of design.

- Nearshore living shoreline
  - Primary objective is wave attenuation and habitat creation
  - Proposed nearshore alignment
  - Three primary regions alongshore (northern lowlands at Thomas Pond, Dagger Point Bluff, southern lowlands at Mustang Lake)
  - High-bluff and low-bluff toe protection concepts
- Project materials
  - Primary design is rock rubble breakwater
  - Additional material considerations for existing lowland areas
    - Oyster/shell-hash gabions
    - Manufactured concrete system

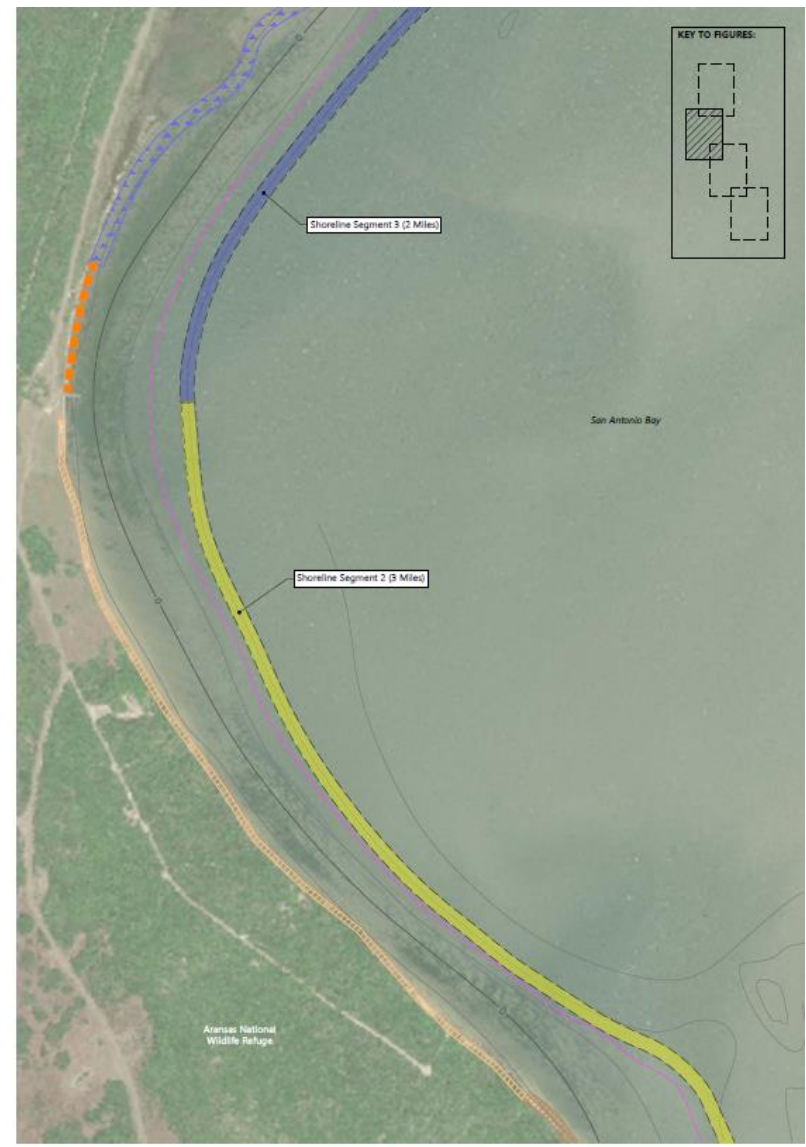
**SOURCE:** ©2019 Microsoft Corporation ©2019 DigitalGlobe ©CNES (2019) Distribution Airbus (DS)  
**HORIZONTAL DATUM:** Texas State Plane South Central, North American Datum of 1983 (NAD83), U.S. Survey Feet  
**VERTICAL DATUM:** North American Vertical Datum of 1988 (NAVD88)  
**NOTE:** Gap spacing and dimensions between breakwater segments to be determined during advancement of design.

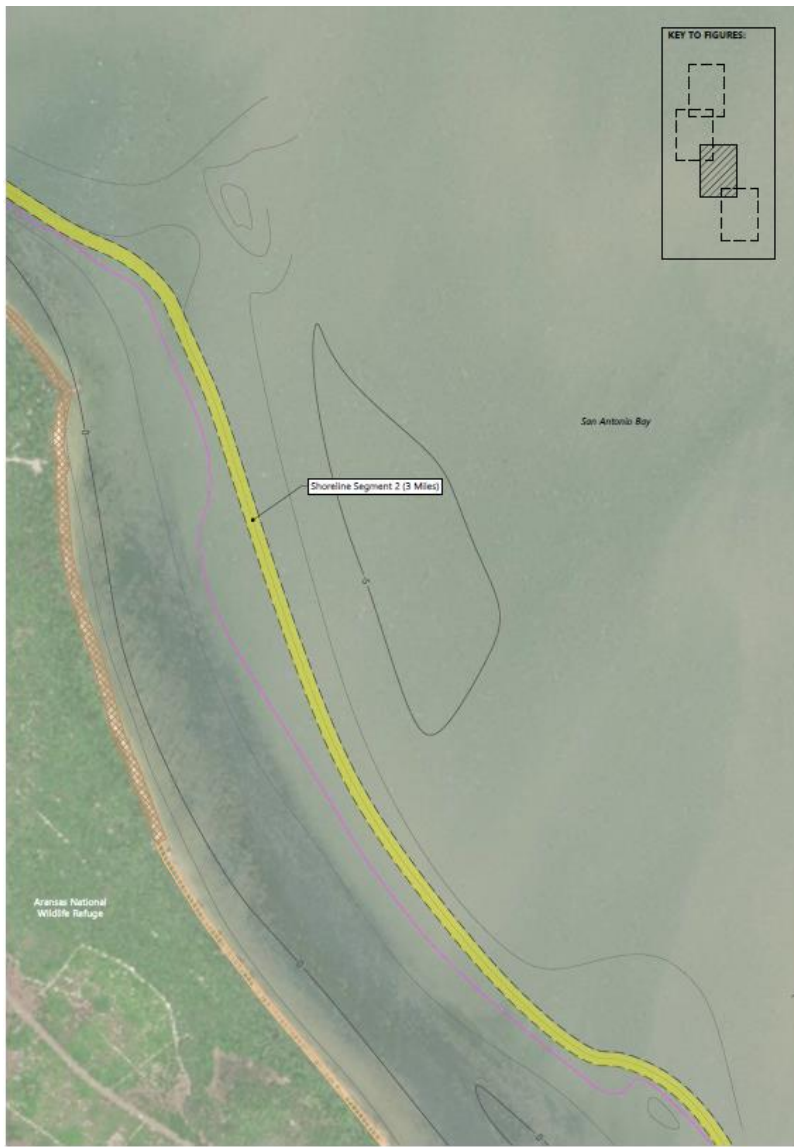
SOURCE: ©2019 Microsoft Corporation ©2019 DigitalGlobe ©CNES (2019) Distribution Airbus (DS)  
**HORIZONTAL DATUM:** Texas State Plane South Central, North American Datum of 1983 (NAD83), U.S. Survey Feet  
**VERTICAL DATUM:** North American Vertical Datum of 1988 (NAVD88)  
**NOTE:** Gap spacing and dimensions between breakwater segments to be determined during advancement of design.

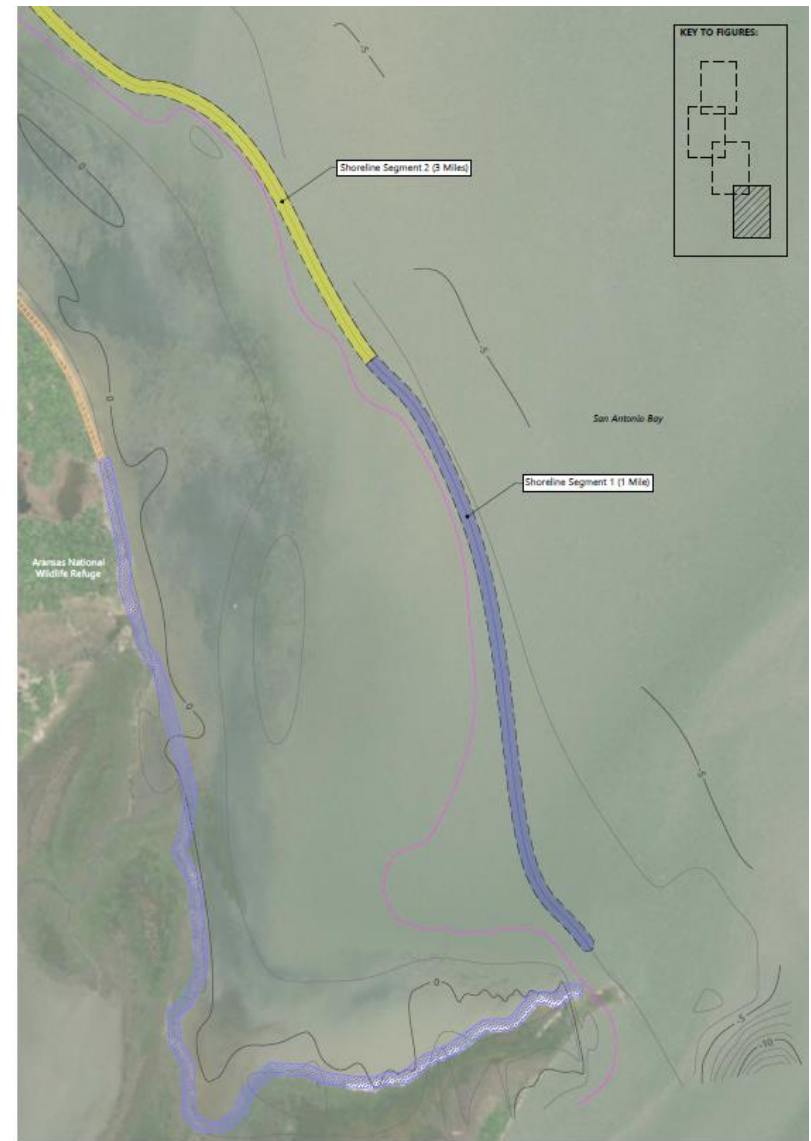
SOURCE: ©2019 Microsoft Corporation ©2019 DigitalGlobe ©CNES (2019) Distribution Airbus (DS)  
**HORIZONTAL DATUM:** Texas State Plane South Central, North American Datum of 1983 (NAD83), U.S. Survey Feet  
**VERTICAL DATUM:** North American Vertical Datum of 1988 (NAVD88)  
**NOTE:** Gap spacing and dimensions between breakwater segments to be determined during advancement of design.
